SAN FRANCISCO BAY NAVAL SHIPYARD  
SAN FRANCISCO, CALIFORNIA 94135

From: Commander, San Francisco Bay Naval Shipyard  
To: Distribution List  
Subj: Report entitled "Health Physics Activities in Connection with the Disestablishment of NRDL: Disposal of Radioactive Material and Termination of AEC Licenses"; forwarding of  
Encl: (1) NRDL Report "Health Physics Activities in Connection with the Disestablishment of NRDL: Disposal of Radioactive Material and Termination of AEC Licenses" of 31 Dec 1969.

TABLE OF CONTENTS

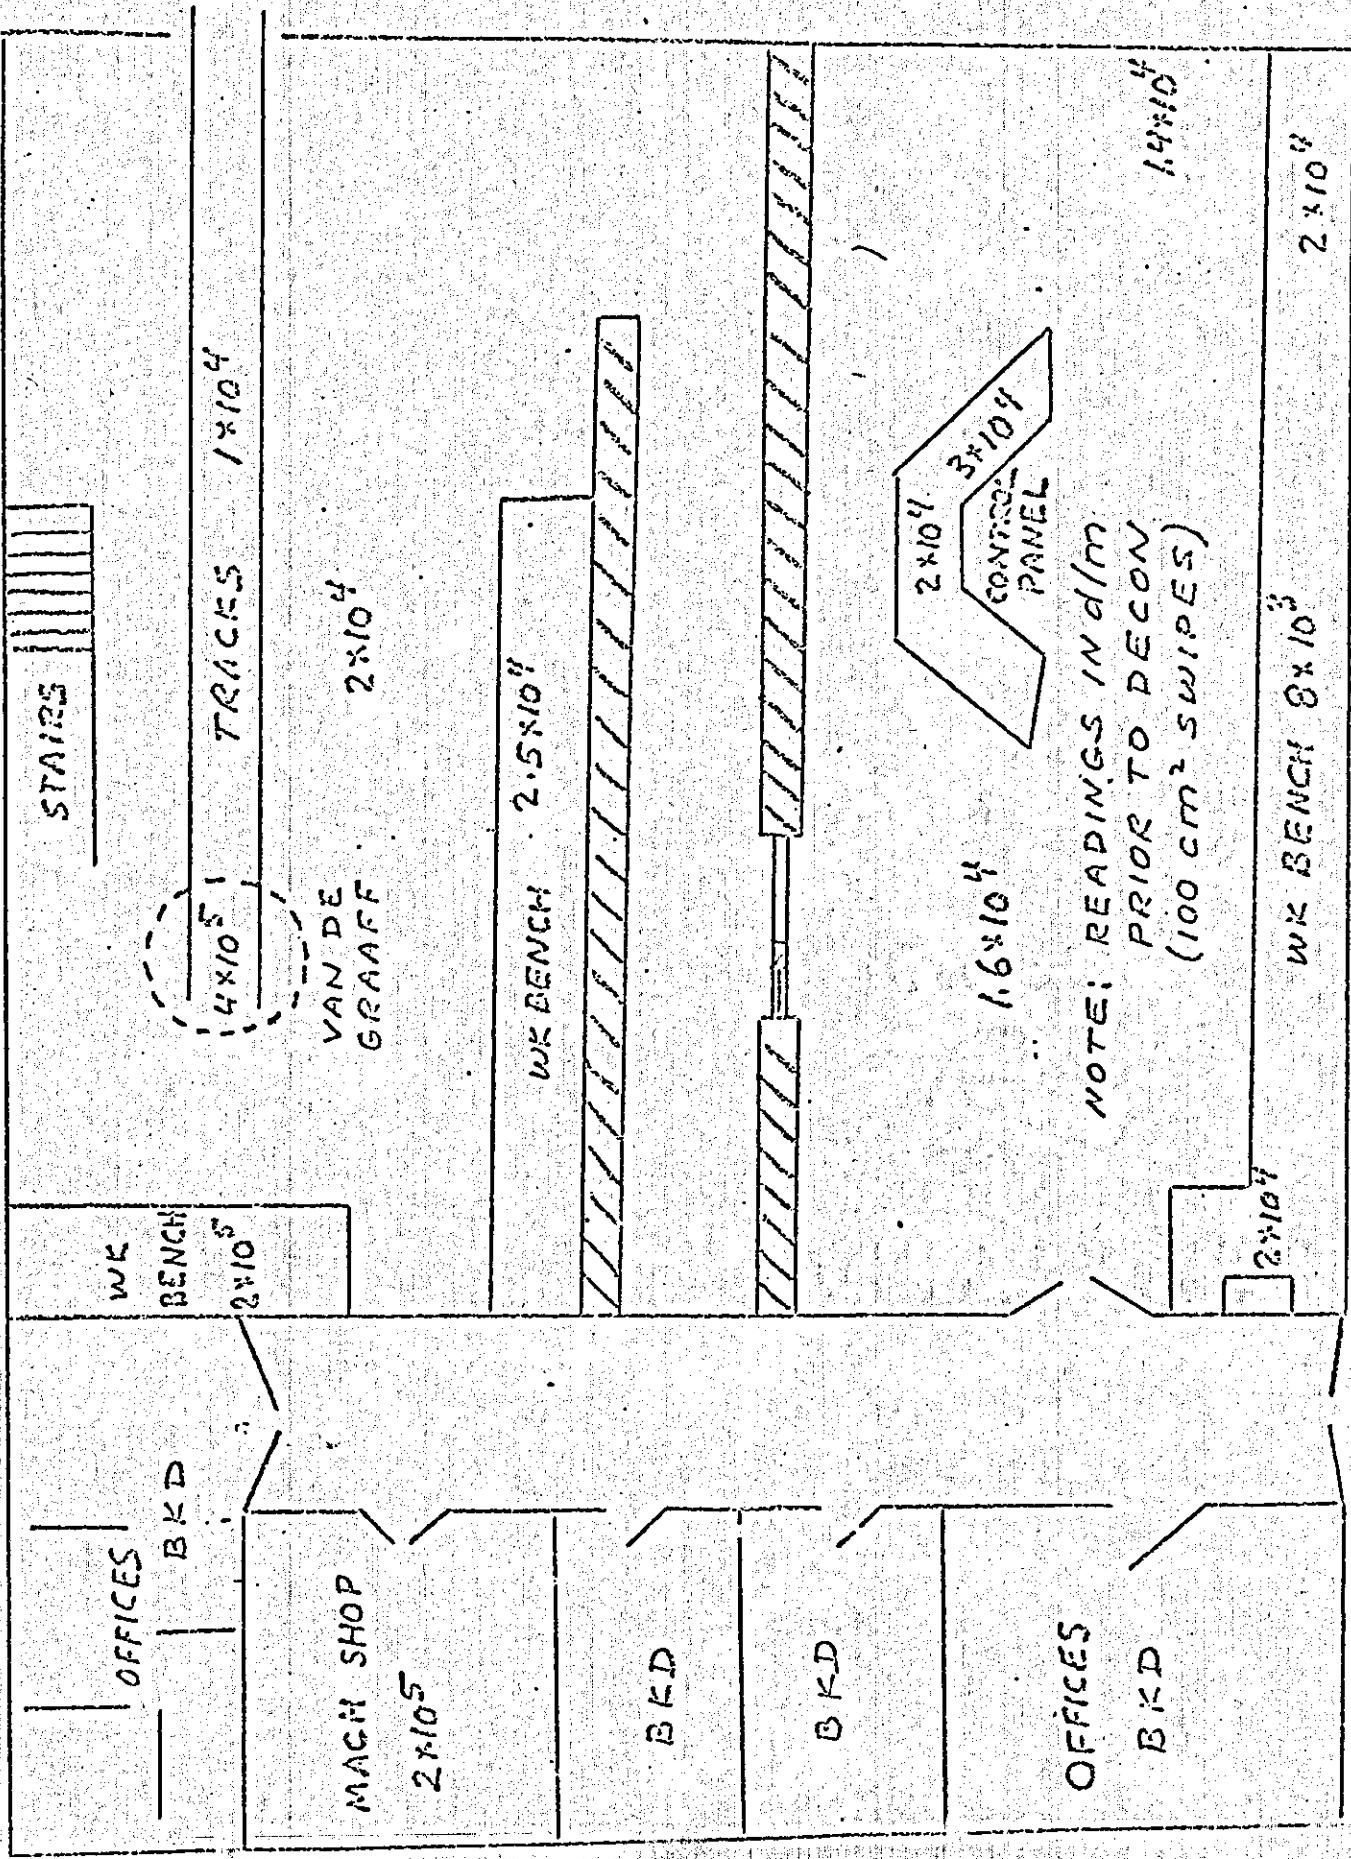
FIGURE 7. TRITIUM SURFACES BLDG 816. 157. DFC

The Van de Graaff accelerator was found to be contaminated with approximately 200 millicuries of tritium. The accelerator was disassembled and shipped as radioactive material to USWID Crane, Indiana where it will be decontaminated and put back into operation.

Following removal of the VDG accelerator and auxilliary equipment the building was steam cleaned for removal of tritium in the concrete walls and floors. Tritium is readily absorbed on porous surfaces and can be driven off into the atmosphere by a combination of heat and high humidity. Swipes were made after the steam cleaning operation in all contaminated areas of Fig. 1 and 2, and in the remainder of the building, including the annex. All counts registered background indicating that the tritium had been successfully removed. An AFC inspection made on Nov 19 indicated no detectable tritium contamination.

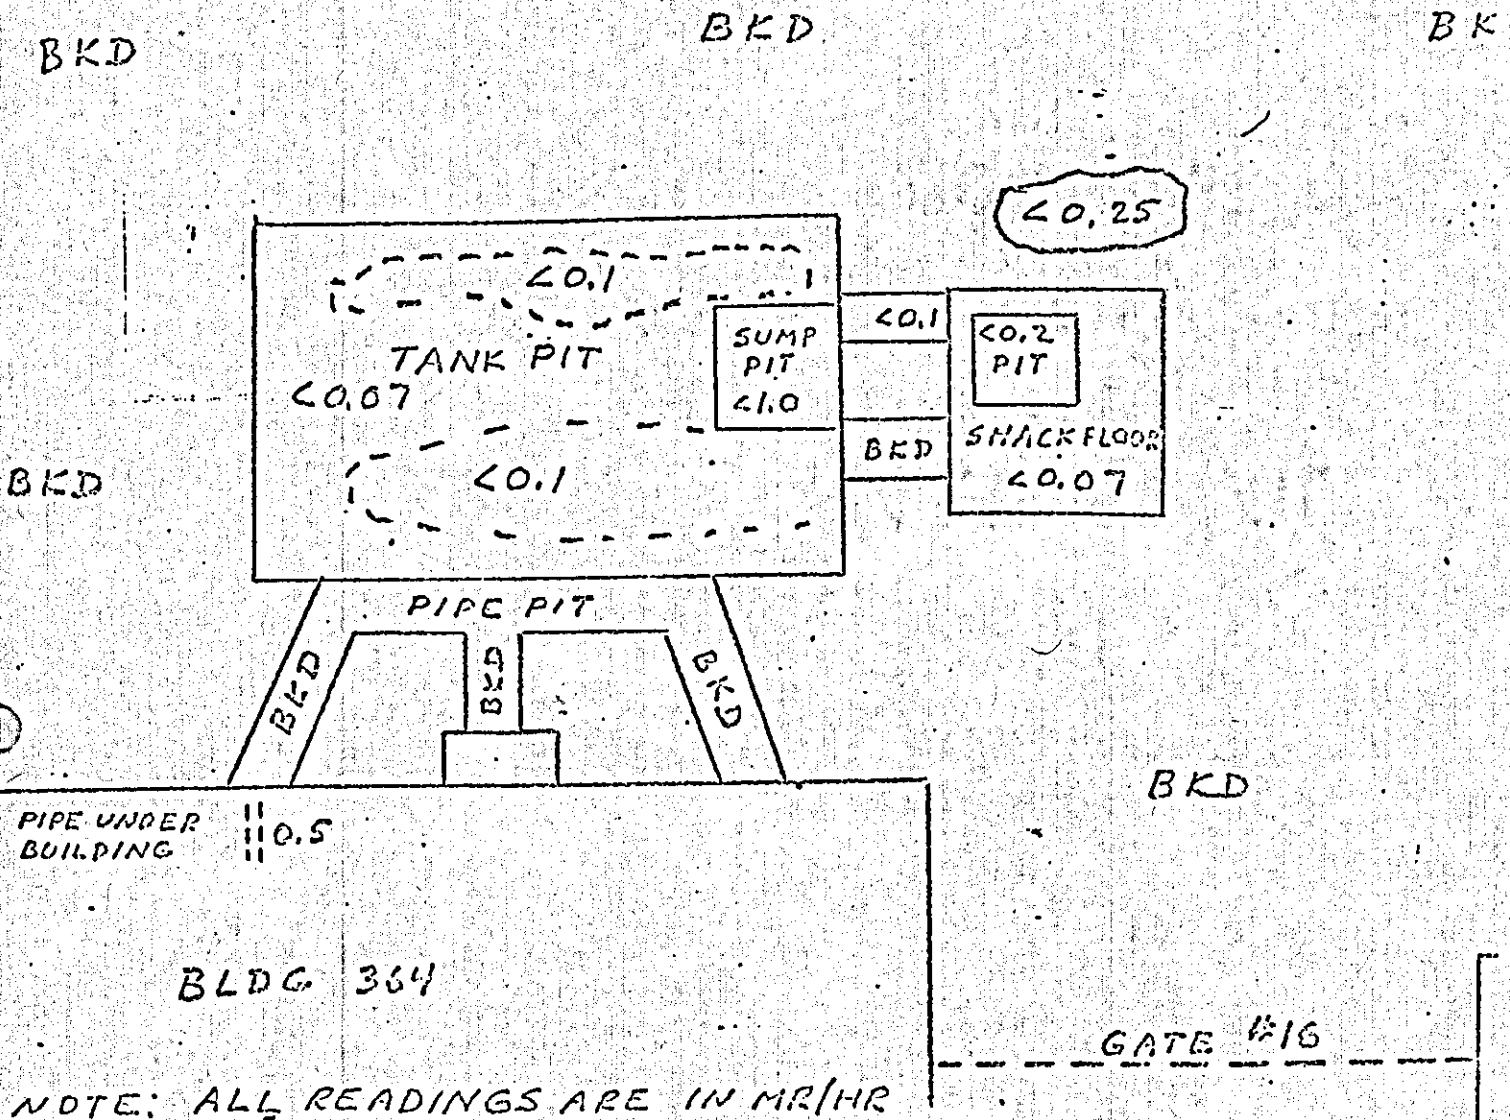
FIGURE 3  
 FINAL RADIATION LEVELS OUTSIDE OF BLDG 364

Radiation levels on the shack floor of the pump shed ranged from 4-6 mr/hr and in the sump pit from 15-20 mr/hr. Decontamination consisted of tearing down the pump shed and all associated plumbing, including the pipes leading to the tank pit. Chipping operations were then performed on the concrete floor and sump pit. Final radiation levels were less than 0.07 mr/hr on the floor and less than 0.2 mr/hr in the sump. Low level activity of less than 0.2 mr/hr was also found in several locations

NOTE: ALL READINGS ARE IN MR/HR  
 ALL SWIPES WERE NEGATIVE

Small amounts of radioactive contamination remain in the yard area behind Bldg 364. These are primarily on the floor of the concrete tank pit and on the shack floor slab. Location of the remaining beta-gamma activity in the yard area may be found in Figure 3.

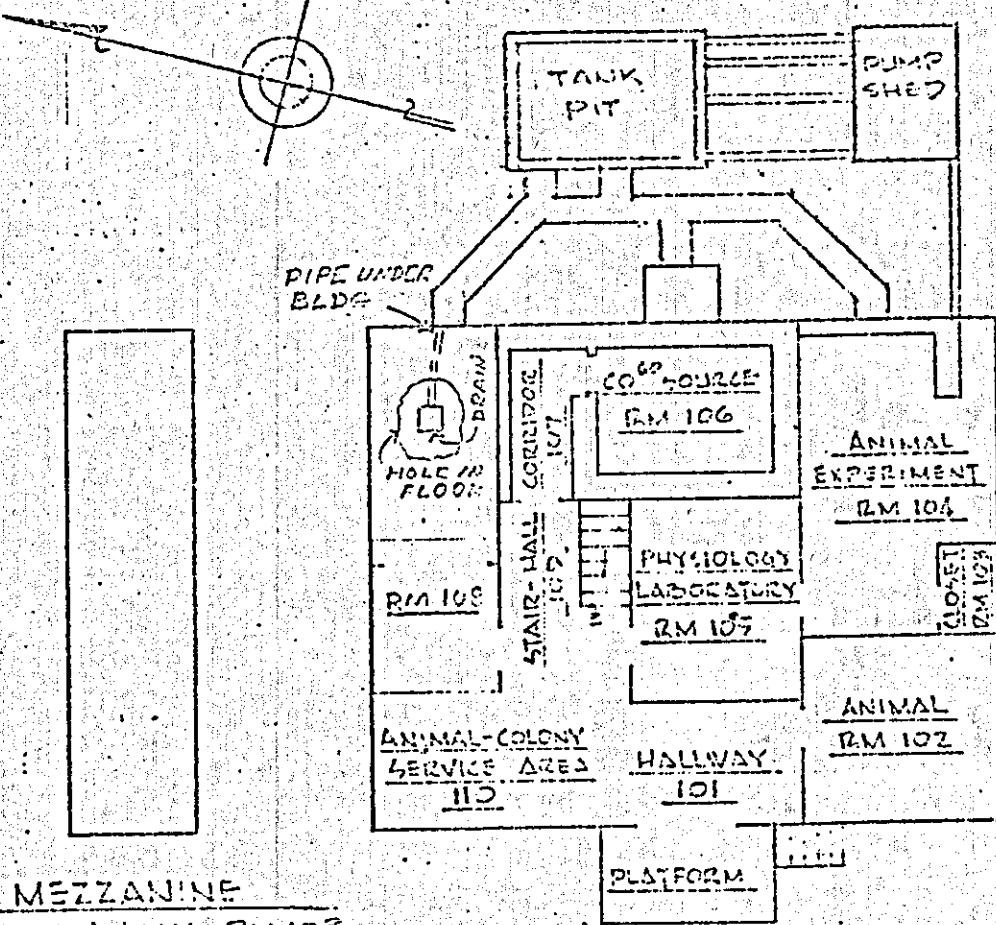
Radiation surveys and swipes were made in the remaining rooms of the first floor and mezzanine (see Figure 4). No detectable radiation was found.

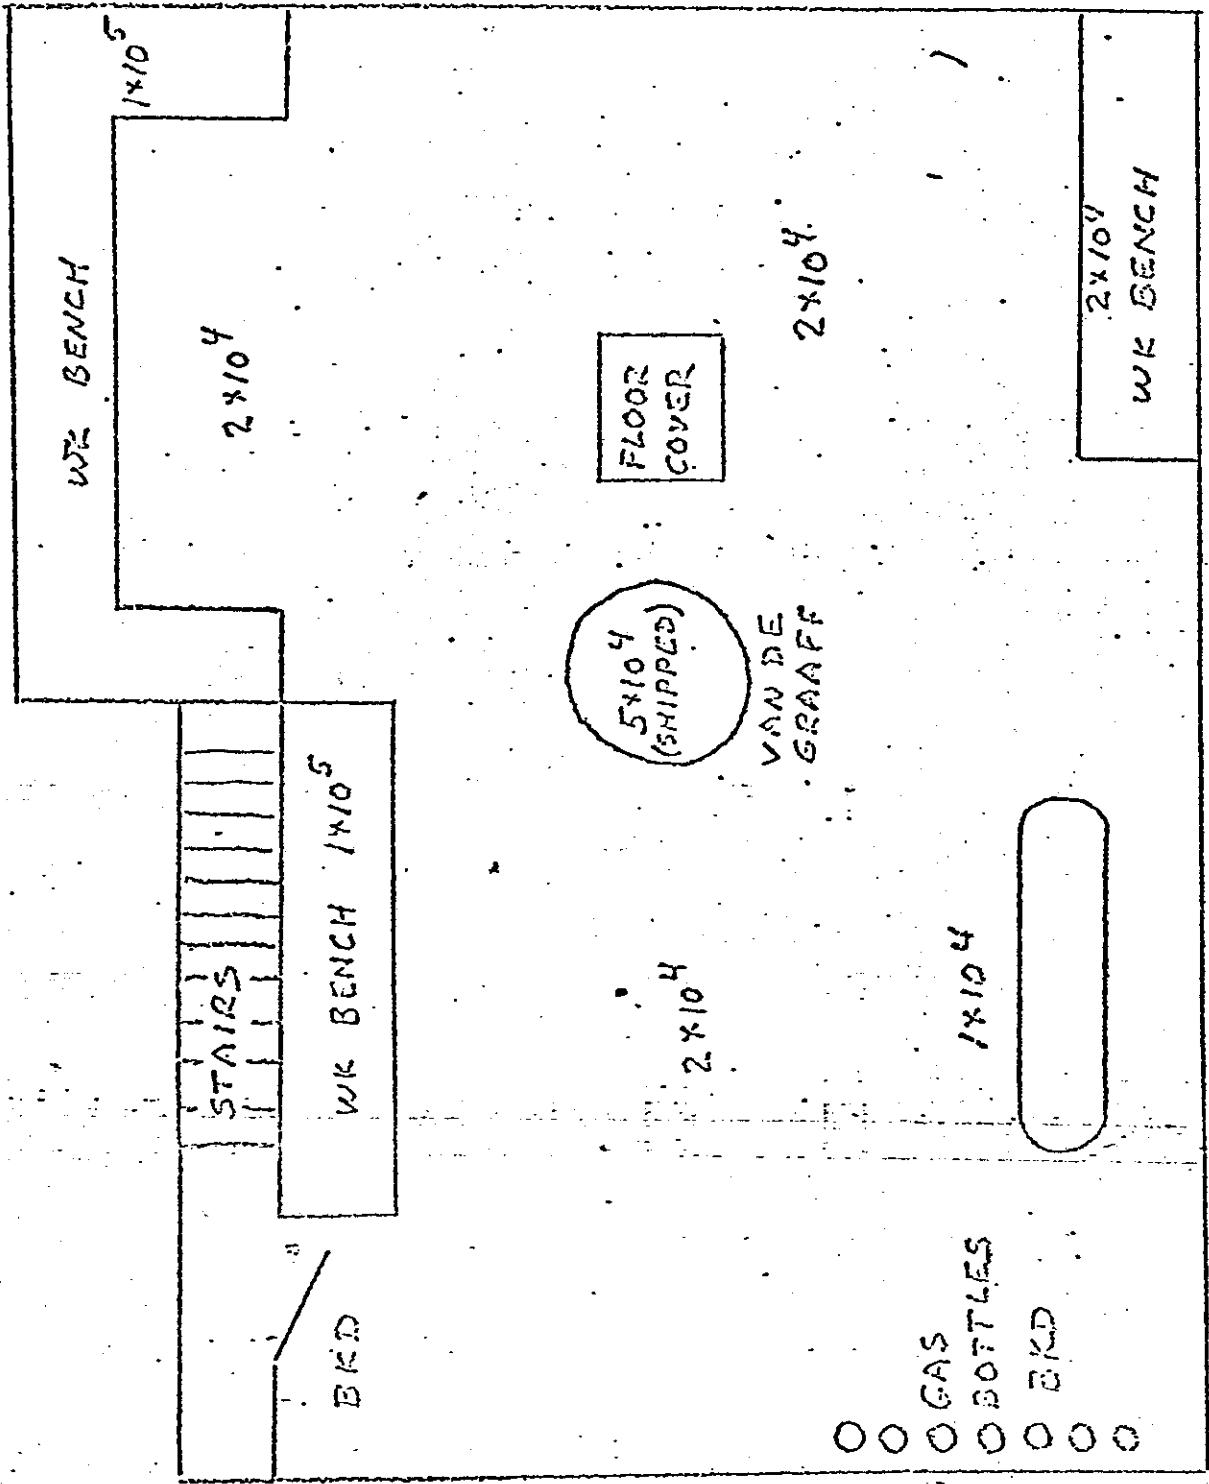
BLDG 816  
 2ND DECK

READINGS IN d/m  
 PRIOR TO DEC CON  
 (100 cm<sup>2</sup> SWIPES)

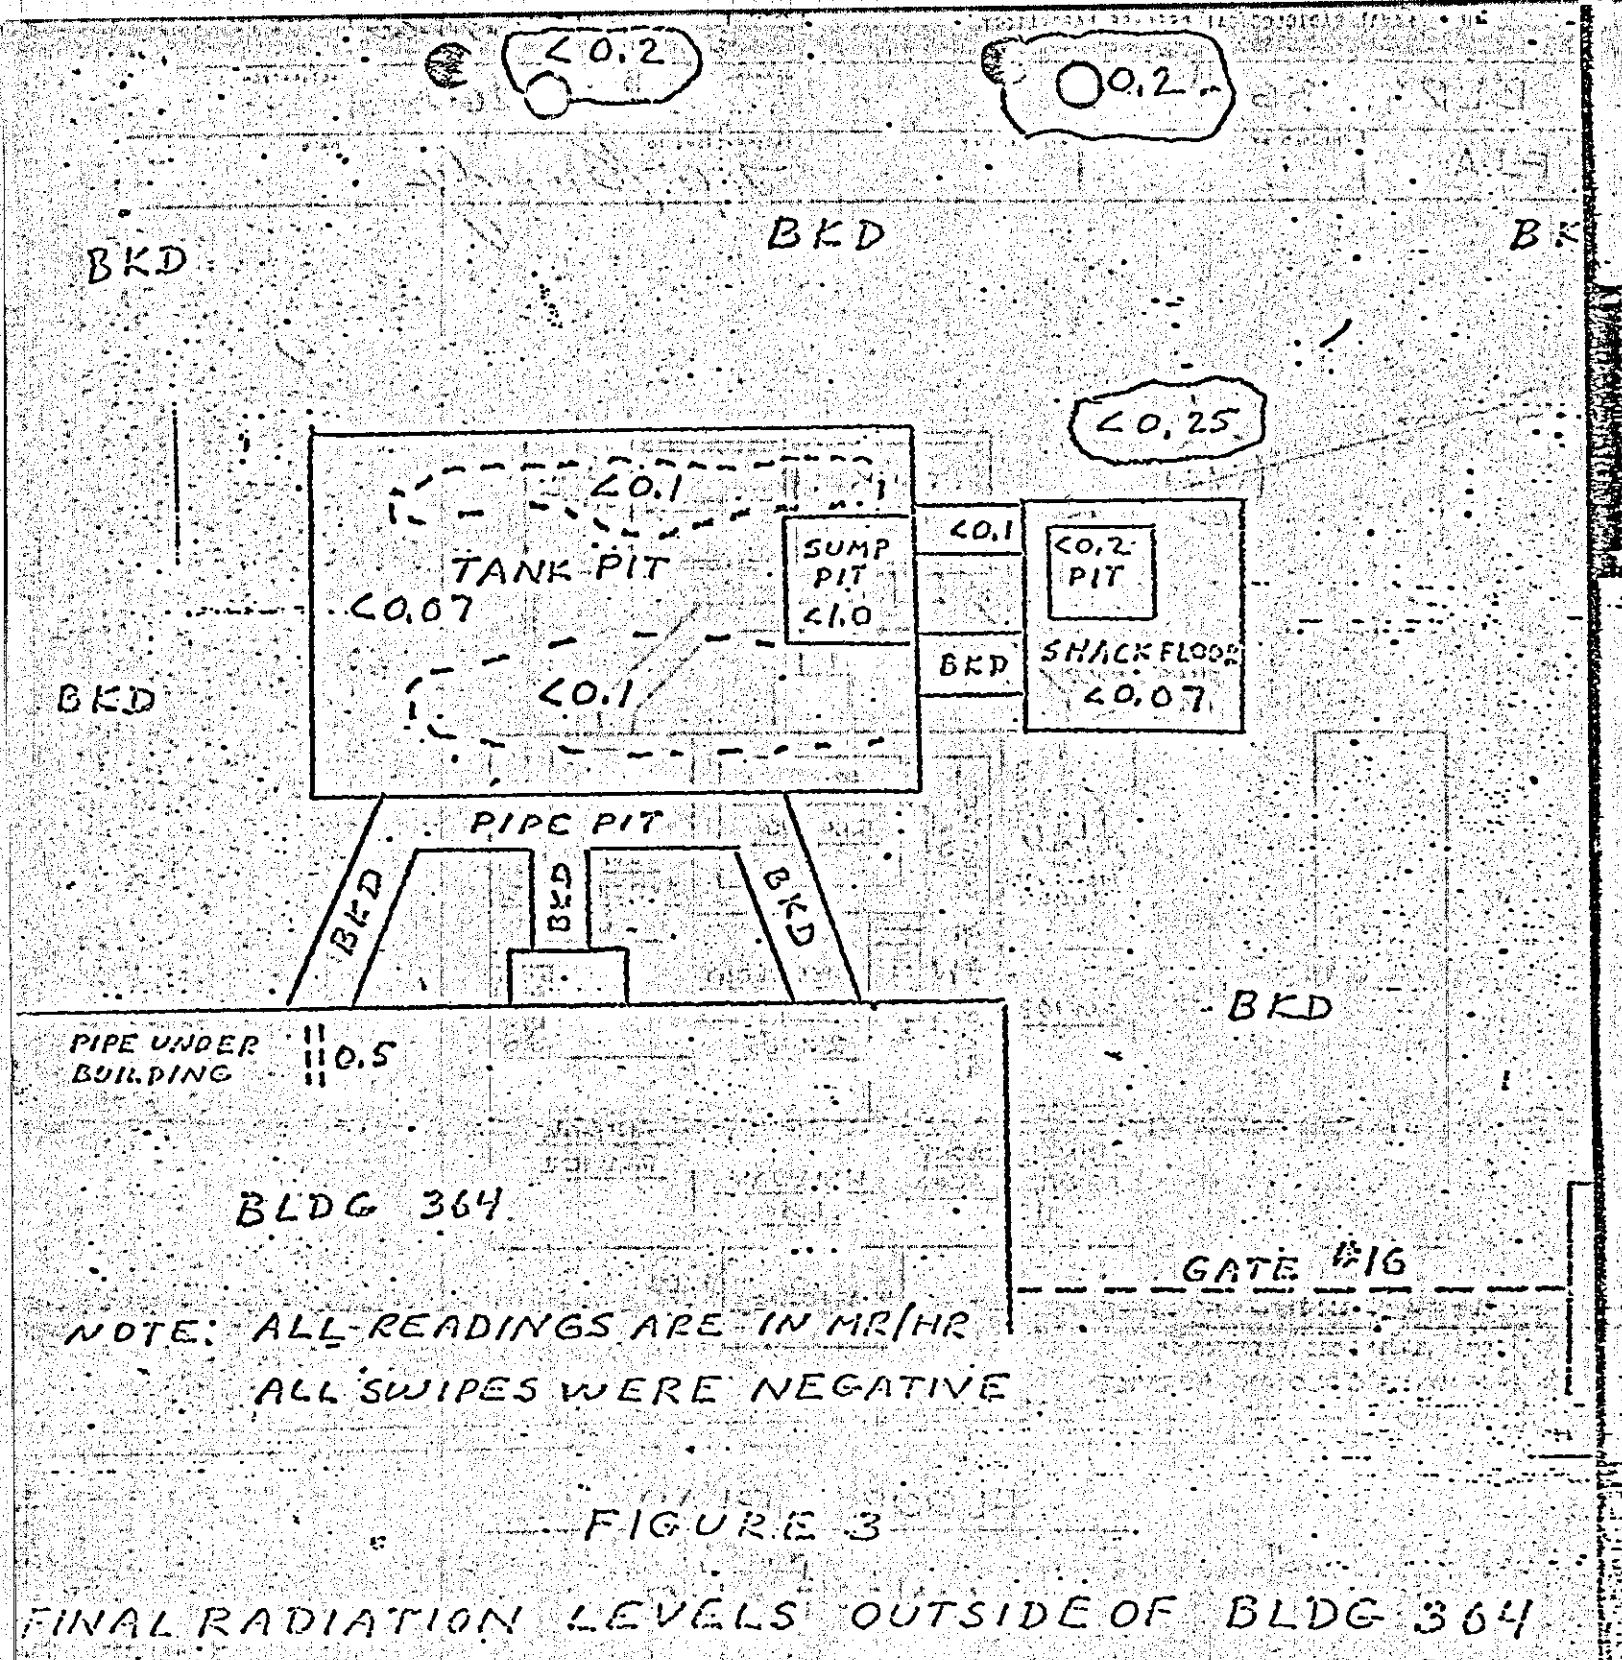
FIGURE 3

FINAL RADIATION LEVELS OUTSIDE OF BLDG 364

Small amounts of radioactive contamination remain in the yard area behind Bldg 364. These are primarily on the floor of the concrete tank pit and on the shack floor slab. Location of the remaining beta-gamma activity in the yard area may be found in Figure 3.

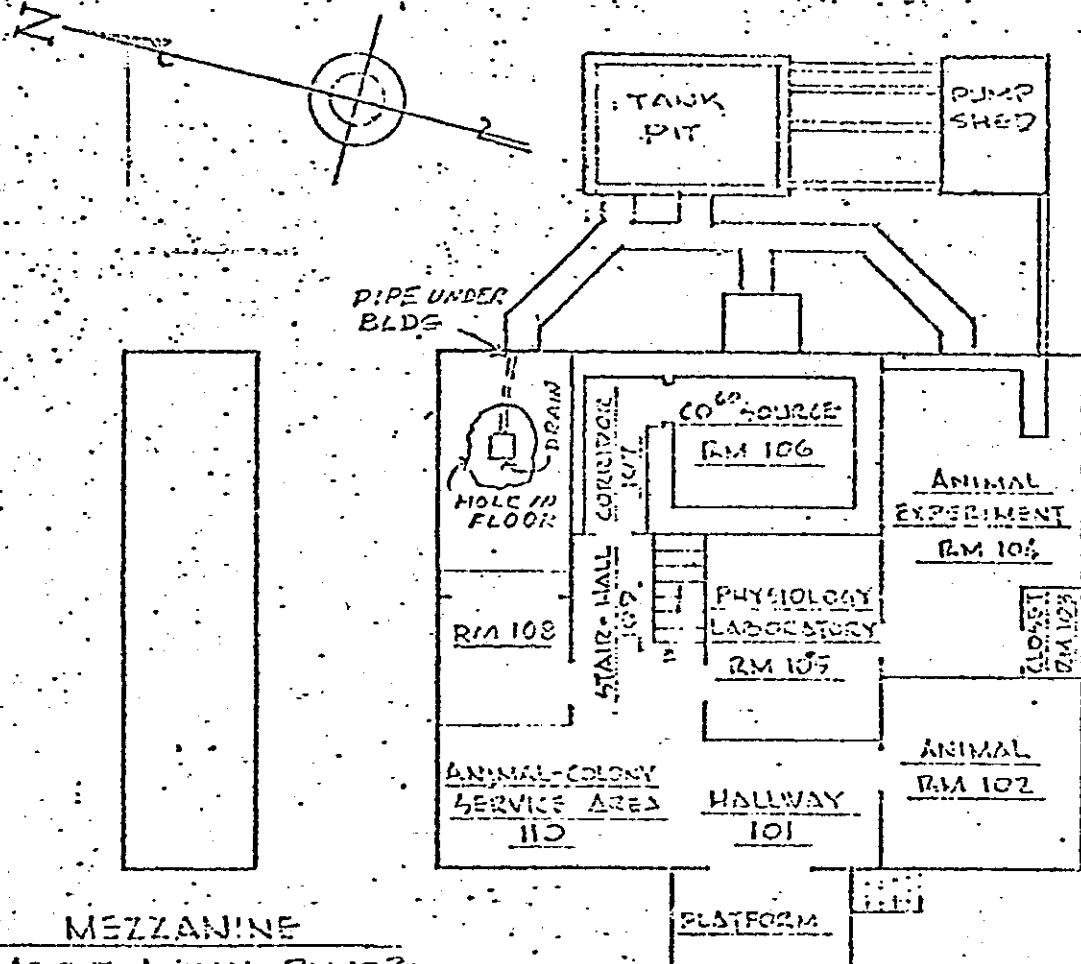
Radiation surveys and swipes were made in the remaining rooms of the first floor and mezzanine (see Figure 4). No detectable radiation was found.
